RAINBOW
PLAY SYSTEMS, INC.®
FINE RESIDENTIAL PLAY EQUIPMENT
500 Rainbow Parkway
Brookings, SD 57006 USA

Report: EUC-12-0108

Certificate of Conformity

Model number or description: EU Original Sunshine Clubhouse Design 4B Commercial WR

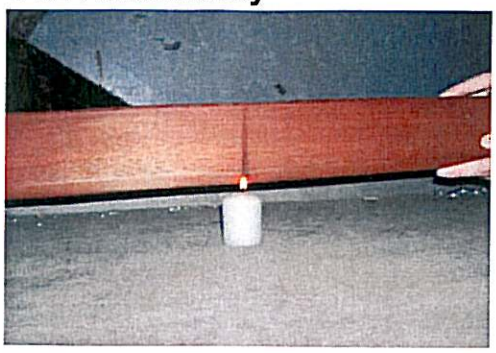
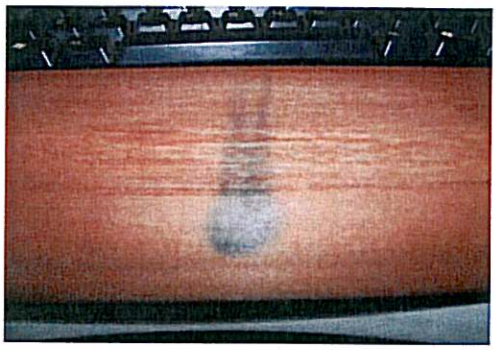
4.1.2 Flammability

Conclusion: A 1.5" diameter candle was used to test the flammability of a board used on this barrier. The candle was lit and the board was held on it for 6 seconds. The board did not ignite.

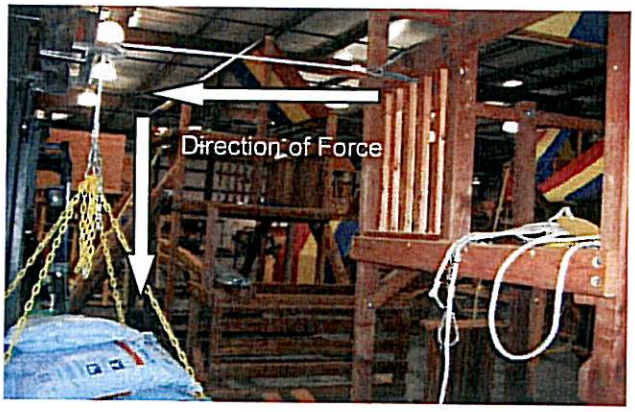
Test: A.2.6.6-Barriers and Guard Rails

The horizontal load on barriers and guard rails is 750 N/m acting in a horizontal direction on the top rail

750N/m=4.28 lb/in
29.25 in x 4.28 lb=125.19 lb

Conclusion: The purpose of this test was to gauge the structural integrity of our barrier. A pulley was used to change direction of force in a horizontal direction. The barrier tested was attached according to installation instructions. An inspection of the barrier was done prior to the test. There were no visible cracks or deformations before or after the test. A load of 136 pounds was applied laterally to the top rail, which surpasses the requirement of 125.4 pounds.

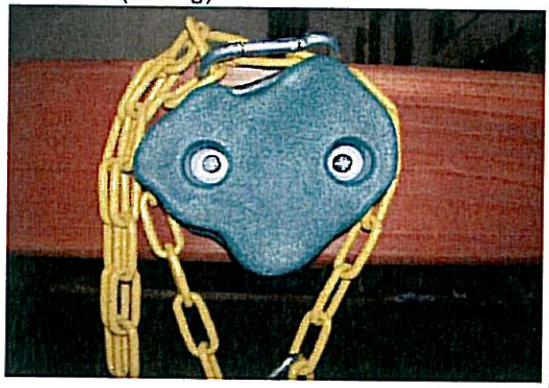
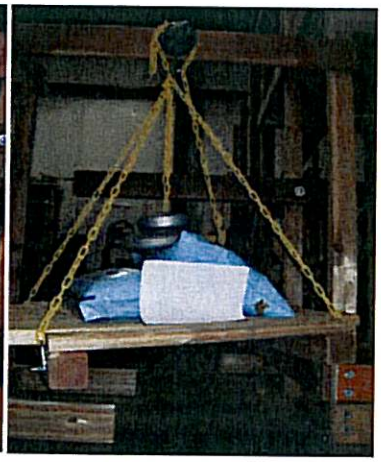
Test A.3.2 Number of users on a point (Rock Wall)

n=153lbs(69.5kg)

Conclusion: A single rock from a rock wall was mounted to a 2x6 piece of lumber according to assembly instructions. A load of 156 lbs (70.76kg) was attached to the rock. This load surpasses the requirement specified in A.3.2

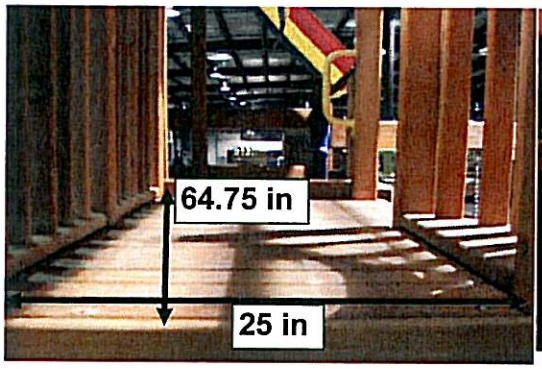
Platform #2 Penthouse Deck =64.75"(1.64m) x 25"(0.635m) = 1619in^2 (1.04m^2)
1.04m^2 / 0.36 = 2.88 => 3
n= 3
$F_{tot;v}$ =2516N (566lbs)

Conclusion: Structural integrity of the penthouse platform was tested using the calculation outlined in section B.3.2. A pre-test inspection was performed. The platform was assembled according to assembly instructions. A load of 600 lbs was applied to the platform and left for 5 minutes. A post-test inspection was performed, and there were no visible deformations.

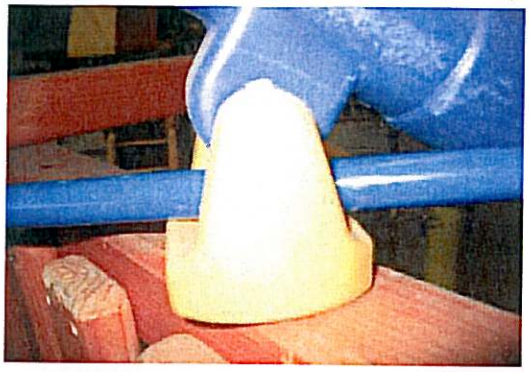
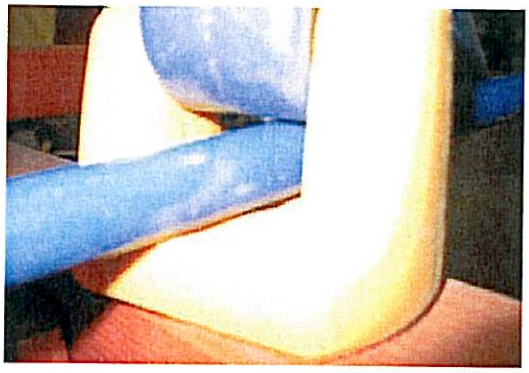
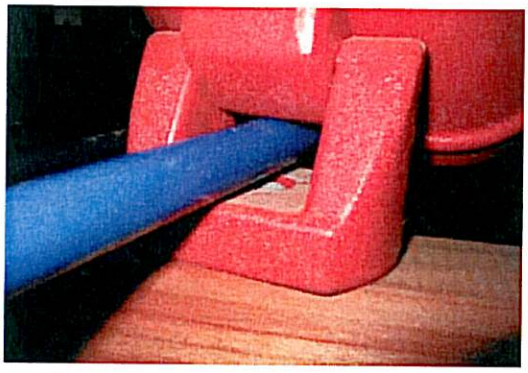
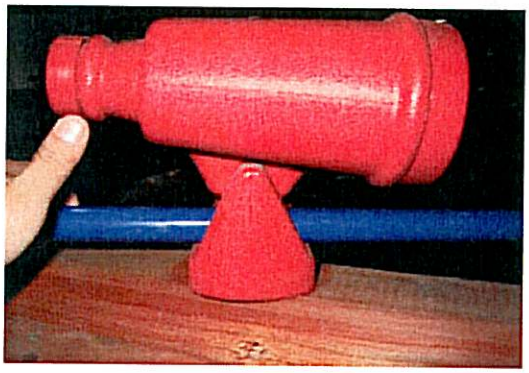
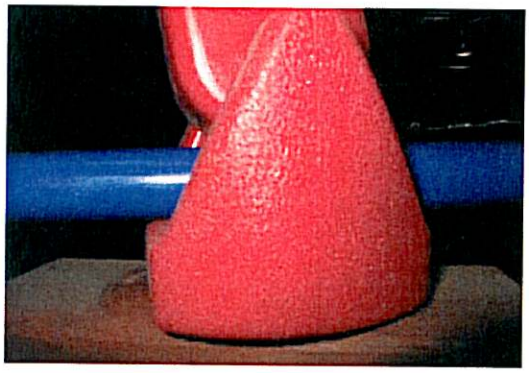
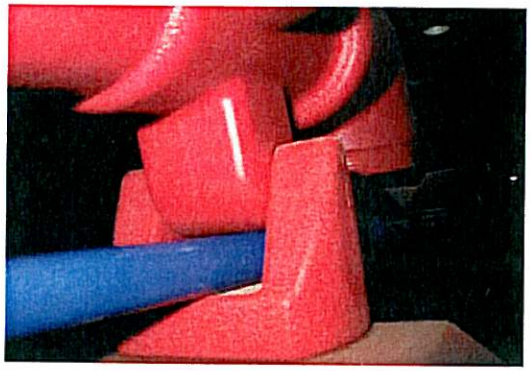
4.2.6 Moving Parts & 4.2.7.6 Entrapment of Fingers

Conclusion: If the 8mm(0.315") rod passes through the opening, the 25mm (1") finger rod shall also pass through the opening, provided that the opening does not permit access to another finger entrapment site.

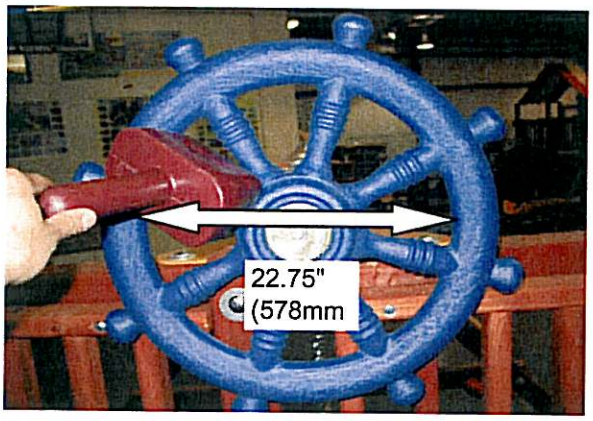
4.2.7 Protection Against Entrapment

Conclusion: The shipswheel does not allow the torso probe.

Conclusion: Probes C or E shall not pass through any opening unless it also allows the passage of the large head probe D. None of the above probes pass through the barrier or under the handles.

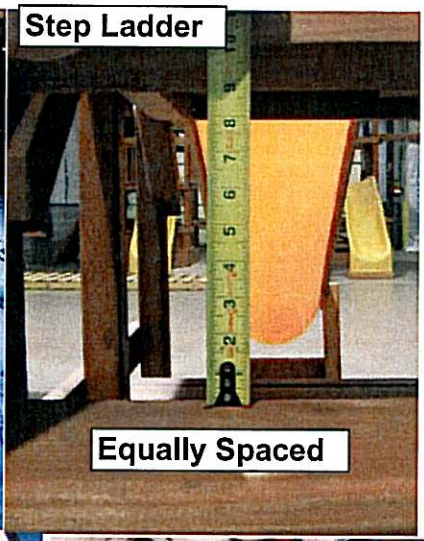
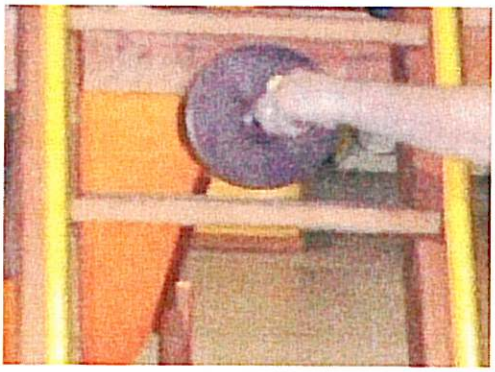
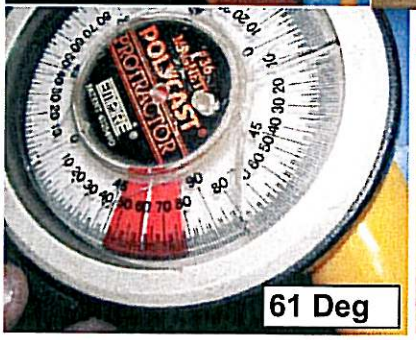
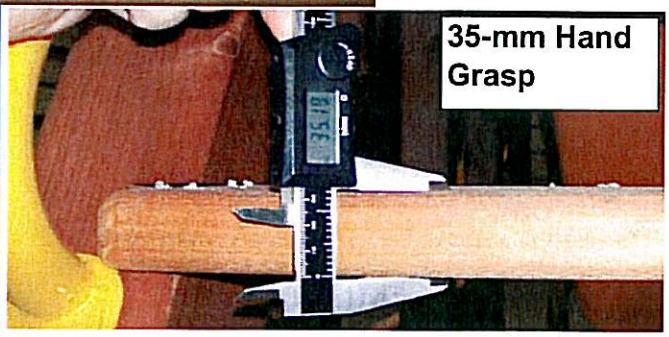
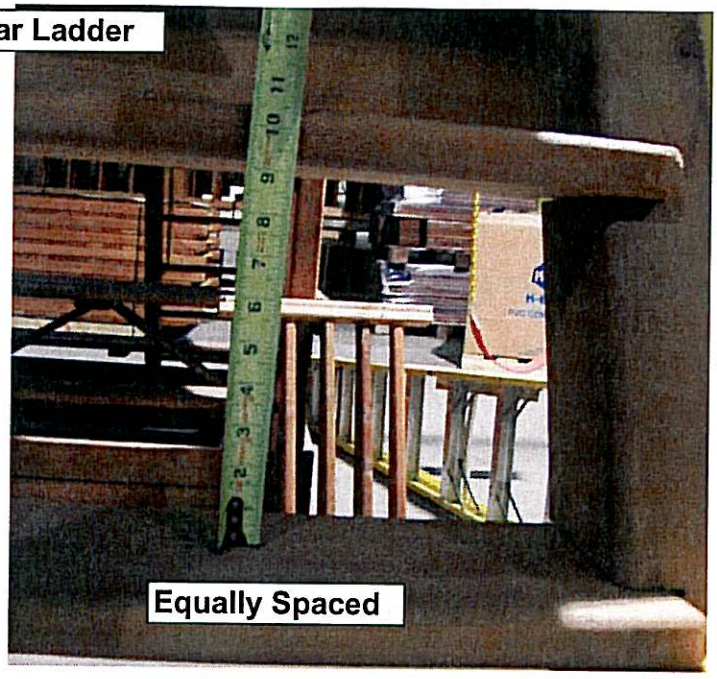
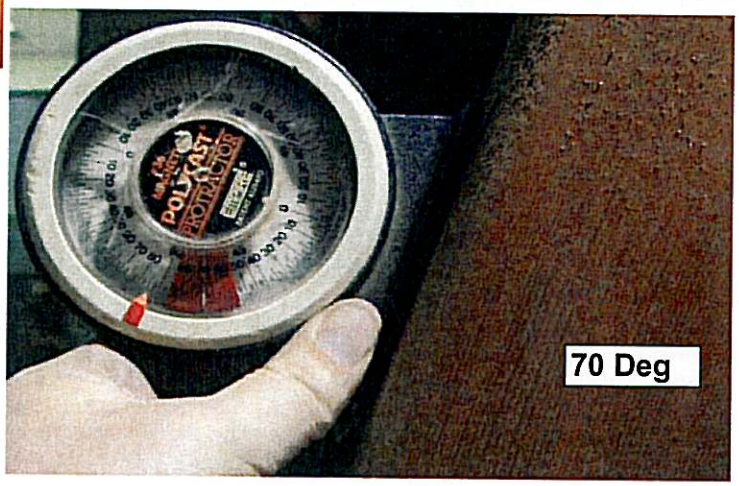
4.2.9.1 Ladders

Ladders shall have steps that conform to the head entrapment requirments, shall be equally spaced, shall have positive connections that cannot be shifter or undone, shall be an unubstructed sape at the rear of the ladder of at least 90-mm from the center of the tread and have treads or that confrom to the requirments for grasp.

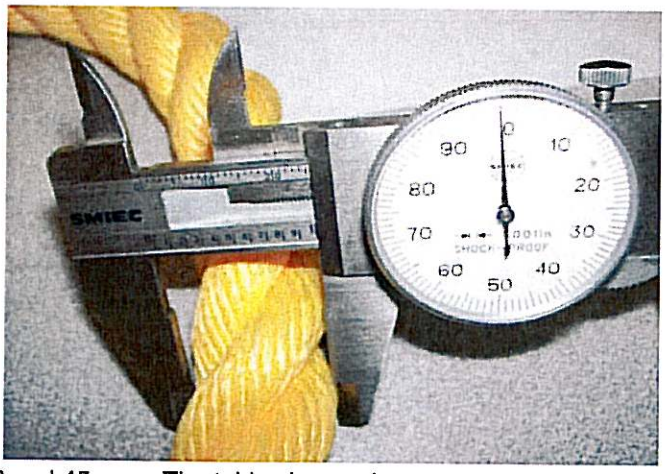
4.2.12.2 Ropes fixed at both ends Climbing ropes

Inches	
1.07	
0.963	
0.975	
0.937	
0.962	
0.9814	**Average width**

Conclusion: The rope diameter shall be between 16 and 45-mm. The table shown above contains measurements taken at different points of the rope. The average dimaeter in (25-mm) .9814 inches

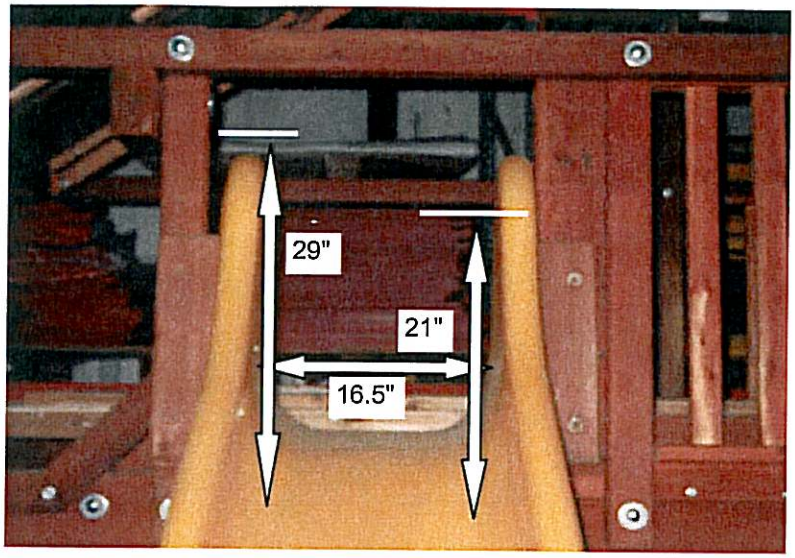
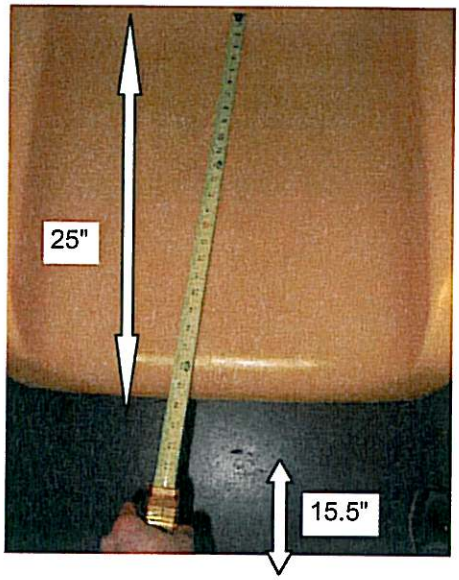
4.4.1 Sliding section: Angle

The angle of declination to the horizontal of the sliding section shall not exceed 60 degrees at any point and shall not exceed an average of 40 degrees. The declination of the sliding section shall be measured from the centerline.
