RAINBOW
PLAY SYSTEMS, INC.®
FINE RESIDENTIAL PLAY EQUIPMENT
500 Rainbow Parkway
Brookings, SD 57006 USA

Report: EUC-12-0109

Certificate of Conformity

Model number or description: EU Original Sunshine Clubhouse Design 5A Commercial

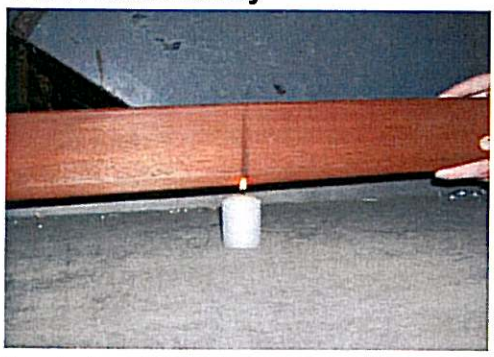
4.1.2 Flammability

Conclusion: A 1.5" diameter candle was used to test the flammability of a board used on this barrier. The candle was lit and the board was held on it for 6 seconds. The board did not ignite.

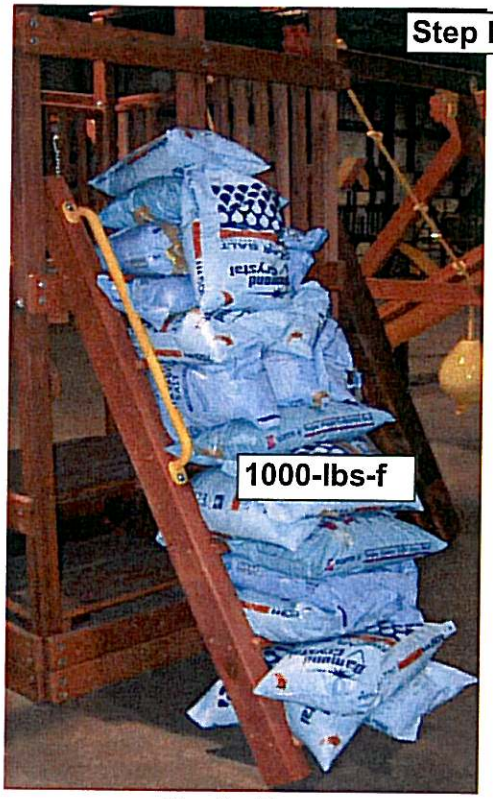
A.2.6.5 Access ladders and stairs

Step Ladder

1 step = 18" x 7" = 126 in^2 .081 mm^2

.081m^2/.36 = .22 => 1 = n

n=6 steps

$F_{tot;v}$ = 984 lbs(3977N)

Discussion and conclusion: A step ladder was tested according to instructions outlined in section A.3.3 and B.3.4. A pre-test inspection found that the ladder was attached according to assembly instructions with no visible cracks or deformations. As calculated, the step ladder was to withstand a force of 3977N(984 lbs-f). The ladder withstood a force of 1000lbs (4448N). This surpasses the requirement of 3977N. A post-test inspection of the ladder and support structure showed that there was no deformations of any kind on the ladder or support structure.

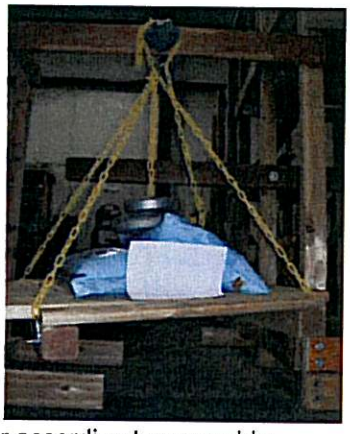
Test A.3.2 Number of users on a point (Rock Wall)

n=153lbs(69.5kg)

Conclusion: A single rock from a rock wall was mounted to a 2x6 piece of lumber according to assembly instructions. A load of 156 lbs (70.76kg) was attached to the rock. This load surpasses the requirement specified in A.3.2

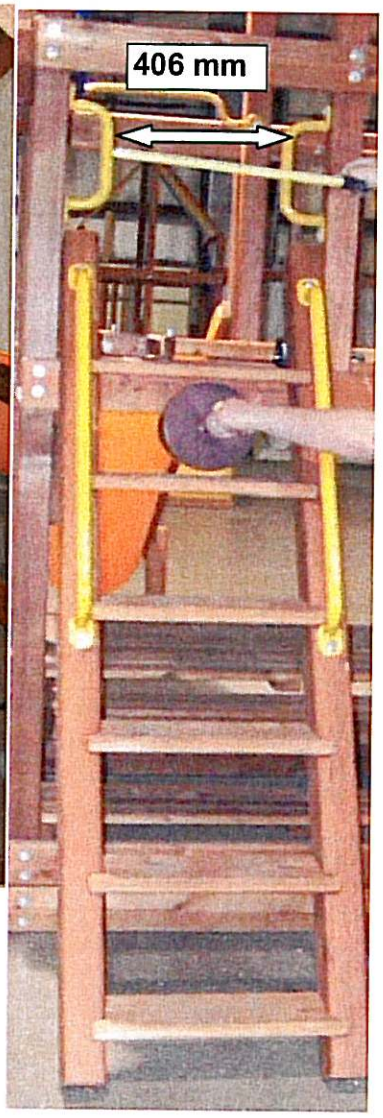
Barriers 4.2.4.4

Conclusion: The exit entrances on both opening must be more than 500-mmwdth of entrance and exit openings in barriers shall have a clear opening of 500-mm maximum unless a guardrail is provided across the opening. The rockwall entrance and exit openings measure 457-mm (18") and the step ladder opening measures 406-mm (16") .

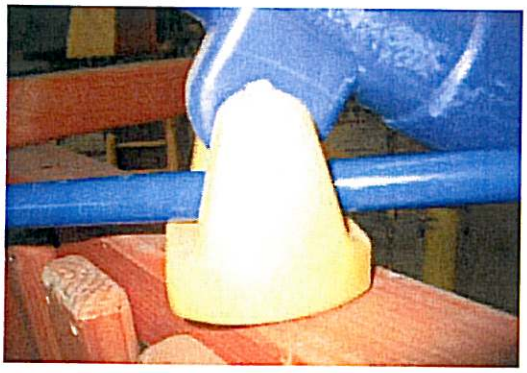
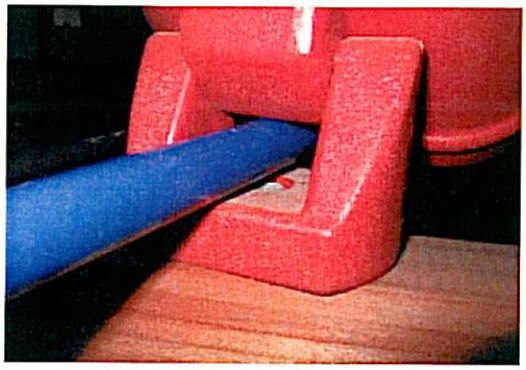
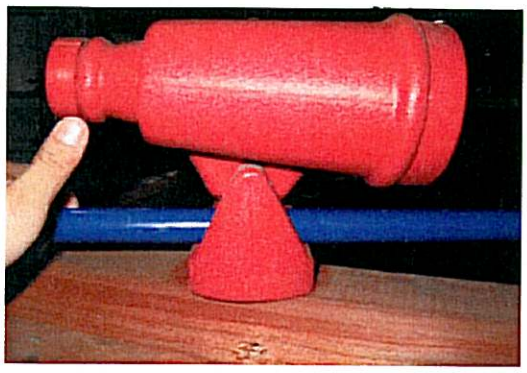
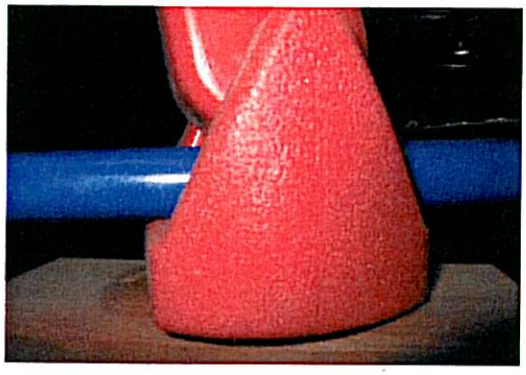
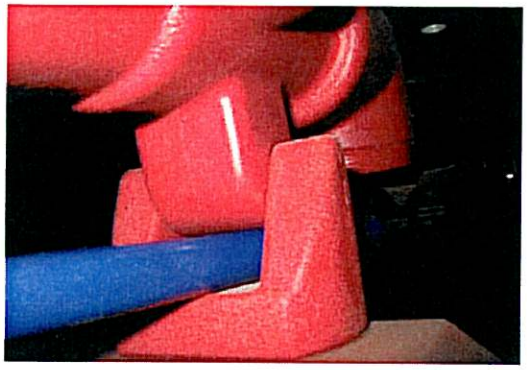
4.2.6 Moving Parts & 4.2.7.6 Entrapment of Fingers

Conclusion: If the 8mm(0.315") rod passes through the opening, the 25mm (1") finger rod shall also pass through the opening, provided that the opening does not permit access to another finger entrapment site.

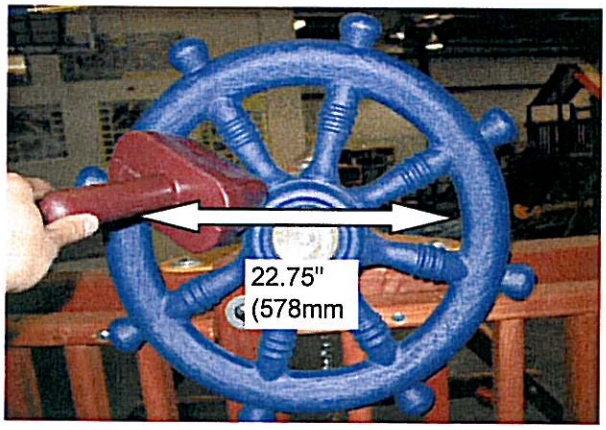
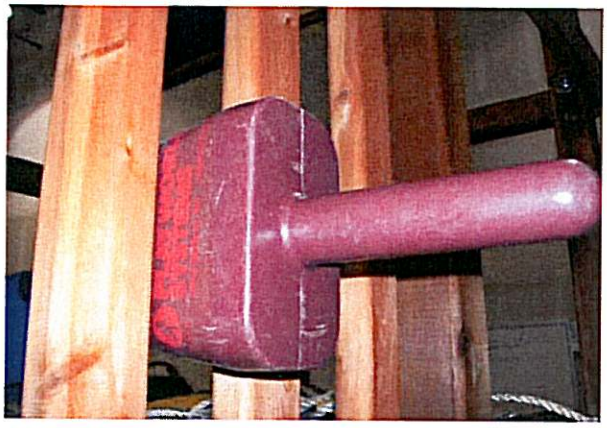
4.2.7 Protection Against Entrapment

Conclusion: The shipswheel does not allow the torso probe.
Conclusion: Probes C or E shall not pass through any opening unless it also allows the passage of the large head probe D. None of the above probes pass through the barrier or under the handles.

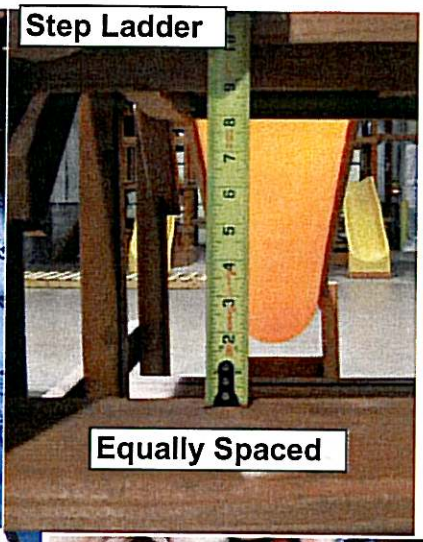
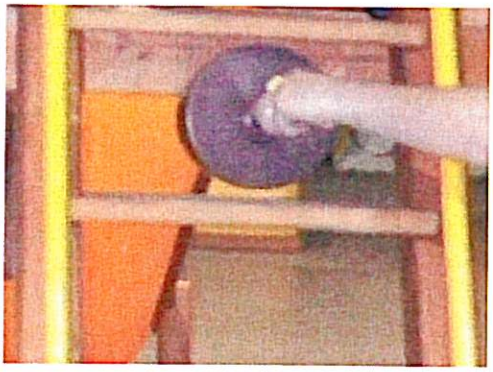
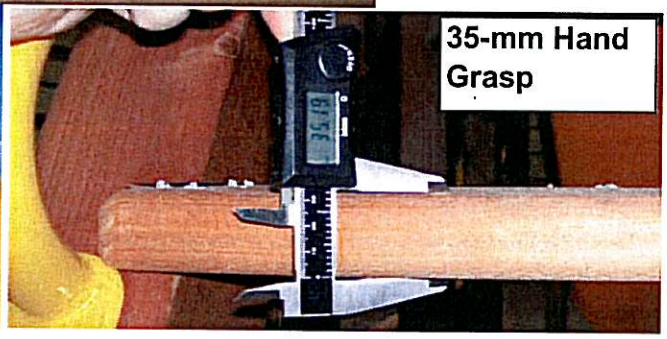
4.2.9.1 Ladders

Ladders shall have steps that conform to the head entrapment requirments, shall be equally spaced, shall have positive connections that cannot be shifter or undone, shall be an unubstructed sape at the rear of the ladder of at least 90-mm from the center of the tread and have treads or that confrom to the requirments for grasp.

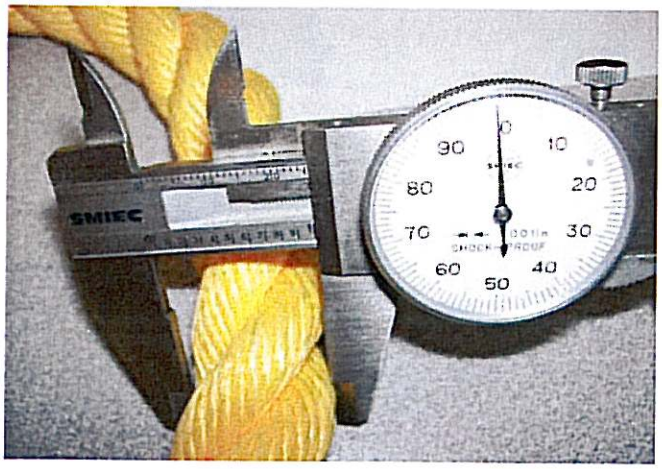
4.2.12.2 Ropes fixed at both ends Climbing ropes

Inches	
1.07	
0.963	
0.975	
0.937	
0.962	
0.9814	**Average width**

Conclusion: The rope diameter shall be between 16 and 45-mm. The table shown above contains measurements taken at different points of the rope. The average dimaeter in (25-mm) .9814 inches

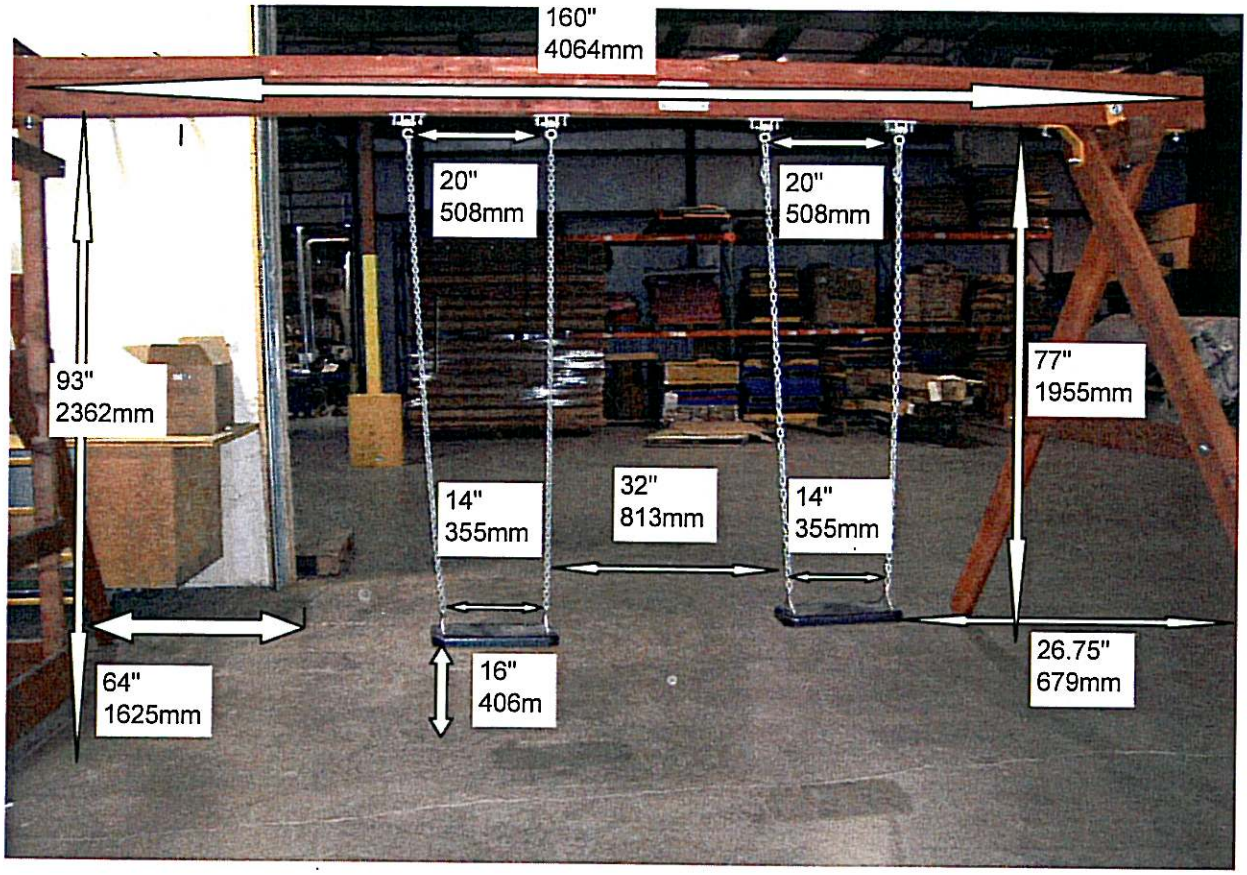
EN 1176-2:2008 Additional specific safety requirments and test methods for swings

4.2: Ground clearance: The minimum ground clearance at rest shall be 350mm
4.4.1 Minimum space between the seats of swings:
Distance between seat of swing and adjacent structure = c≥20%l+200mm
391 + 200mm = 591mm

Distance between adjacent swing seats = s ≥ 20%l + 300mm
391 + 300mm = 691mm

4.4.2 Stability of swing seats: The distance between suspension members shall be F, where F ≥ G + 5%l
355 + 98 = 453mm

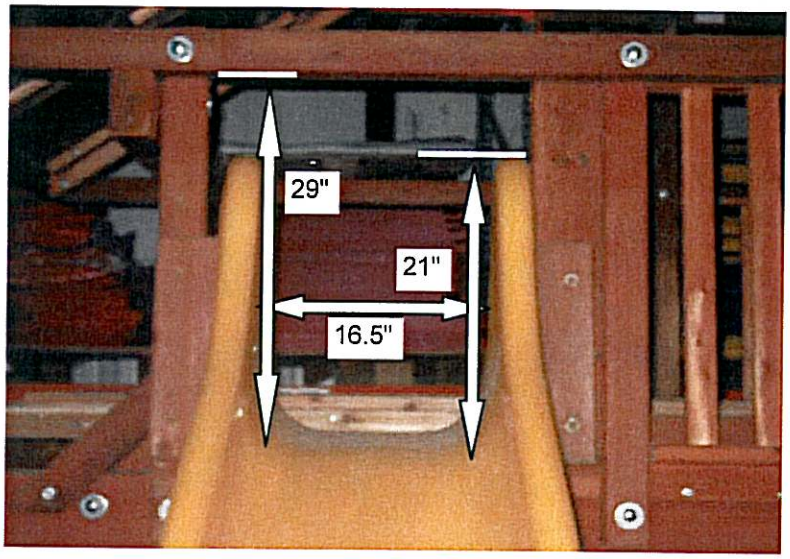
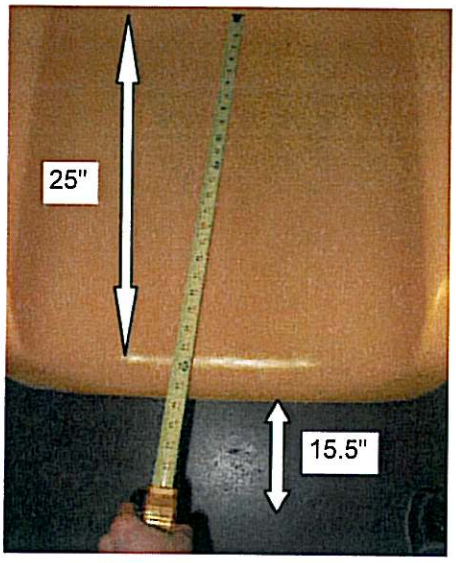
EN 1176-3:2008 Additional specific safety requirments and test methods for slides

4.4.1 Sliding section: Angle

The angle of declination to the horizontal of the sliding section shall not exceed 60 degrees at any point and shall not exceed an average of 40 degrees. The declination of the sliding section shall be measured from the centerline.
